Pye Green Community Centre Roof Report

March 2026

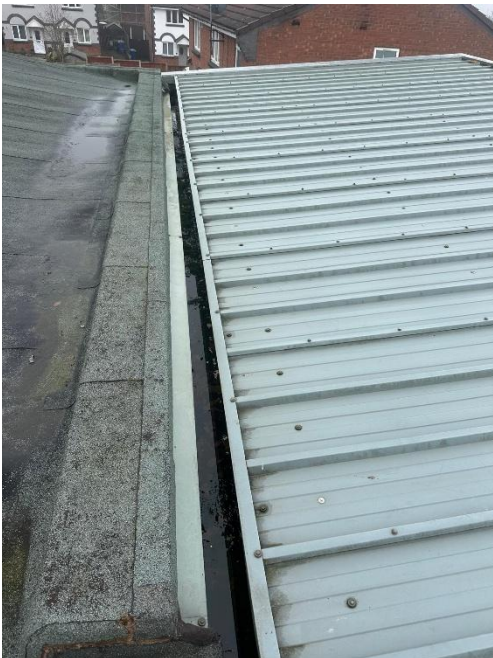
Figure 1

As the weather had improved, we requested another site visit by the roofers. We asked them to provide pictures for Council to assist. They reviewed the metal valley that runs between the metal roof areas and abuts the flat roof. The valley drainage is located at the MR1 meeting room end, not the end where the leaks are occurring. The valley was found to be full of sludge / debris / moss which they cleared out whilst they were here. Having looked at where the leaks are, they believe the valley between the metal and non-metal roofing (this is outside of the main flat roof) is the causation of the leaks over winter. (Figures 1 and 2) as the water was not running down to the MR1 end as it should have been.

Roof gulley length with drainage at MR1 end

The PGCC caretaker is monitoring how much and where water comes through now that the valley has been cleared. If the problem re-occurs, the roofers have suggested that the metal valley may need replacing and the end closest to the flat roof raised sufficiently for the water to run off. They have recommended this be replaced with aluminium. They also recommended that the valley be cleared out regularly 3-4 times per year to ensure that the water disperses quickly.

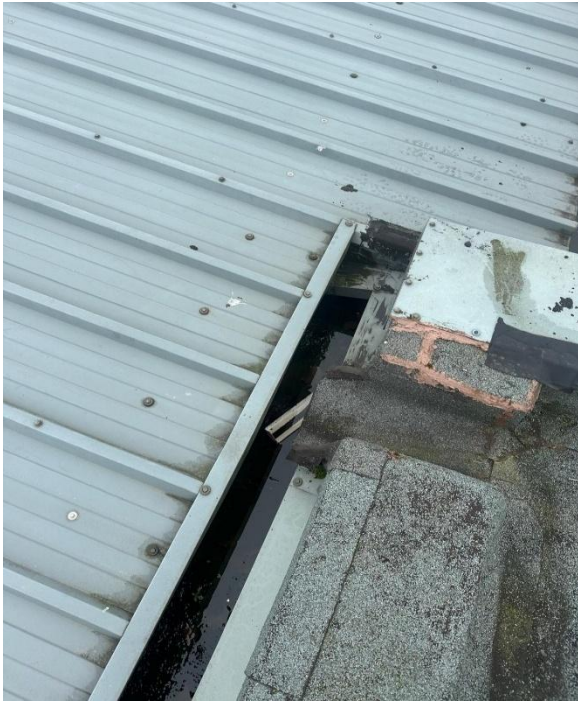
Figure 2

The configuration of the valley above the foyer (corner by leaflets in the reception area). Drainage opposite end.

The valley drainage should run to the end by MR1 but is potentially running back towards the main roof rather than running away. Whilst they were here, this was cleared out as best as possible and should improve the situation so that water runs away freely.

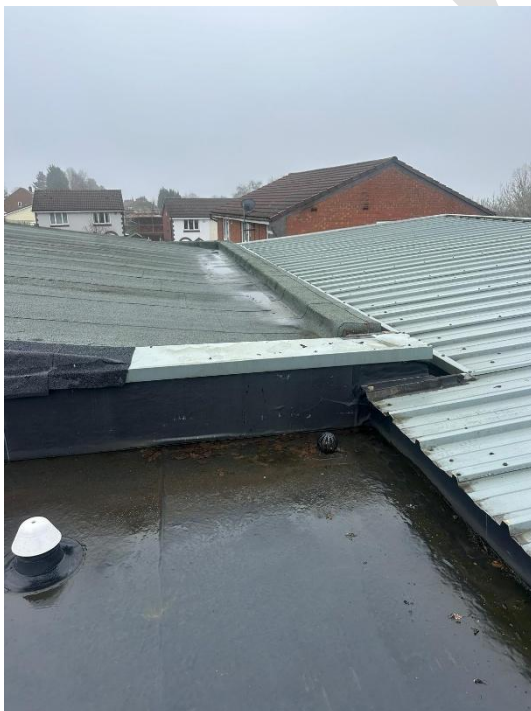
Figure 3, flat roof side overview.
